# **Estonian EU External Borders Programme (ER3) Research Results**

### Archaeological research of building remains in the Western Courtyard of Narva Castle between 2020–2023

### Bastions of Narva Castle

### Narva Gloria Bastion archaeological research 2023

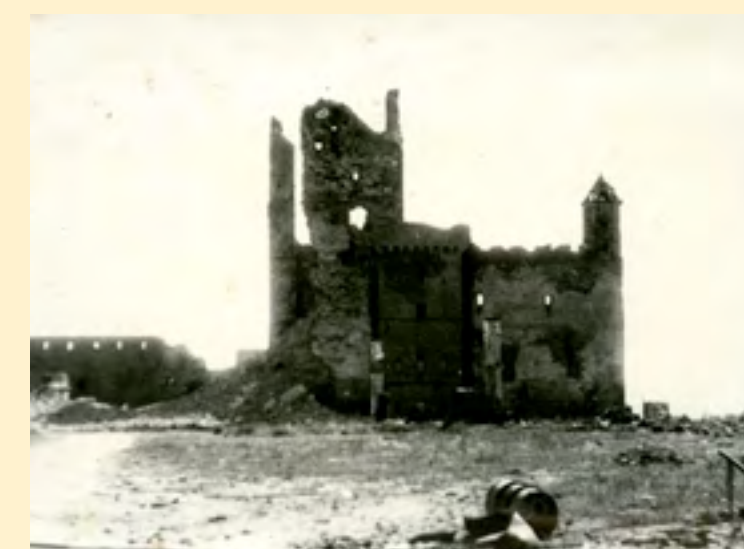
3 Narva Castle after World War II. 1944–1947. Narva Museum

It was because of the war that the unique complex of fortresses suffered 80 years ago. By the end of World War II, the remains of the majority of buildings in Narva Castle were only ruins and outer walls. During the first postwar years, these ruined structures kept decaying due to the lack of activities aimed at fixing those. (Images 3, 4)

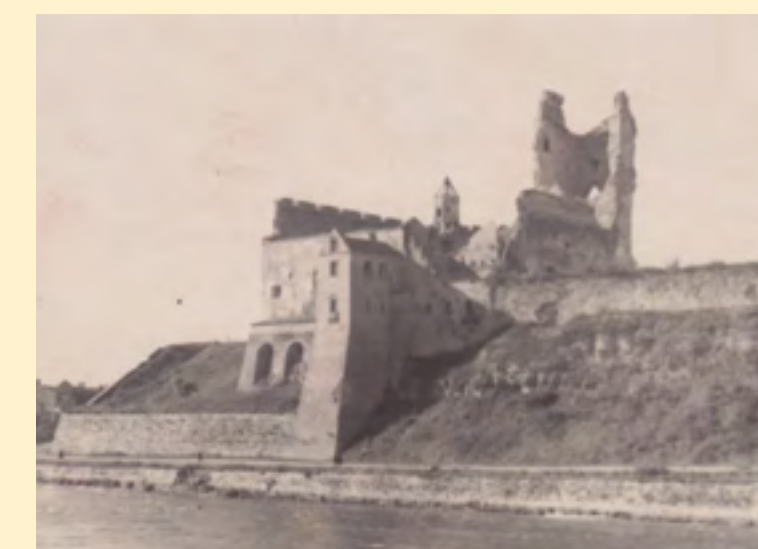
4 Narva Castle after World War II. 1950–1960. Narva Museum

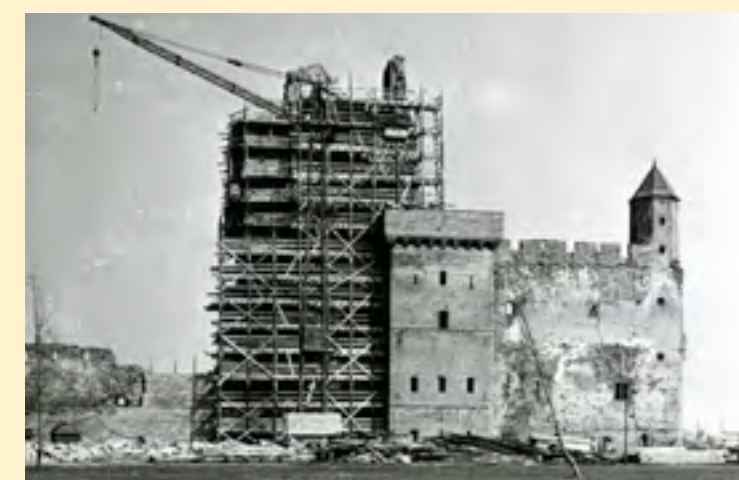
5 Restoration of the Hermann Tower. 1980. Narva Museum

Preparation for the restoration of Narva Castle started in the 1950s, but the start of the systematic restoration works dates back to 1968. By the end of the 1980s, the restored structures were Tall Hermann tower, the southern and the western outbuildings of the Convent house, the Rondell tower and the stone hall (Image 5). At the same time, an important stage of the western courtyard restoration was implemented that involved the construction of the western wall and the defensive passage, fortification of the Kristervall half-bastion with casemates. Inside the earthfill of Kristervall, a middle age tower was found, that was further cleared out and conserved. It was left in the state it was as a tourist attraction.

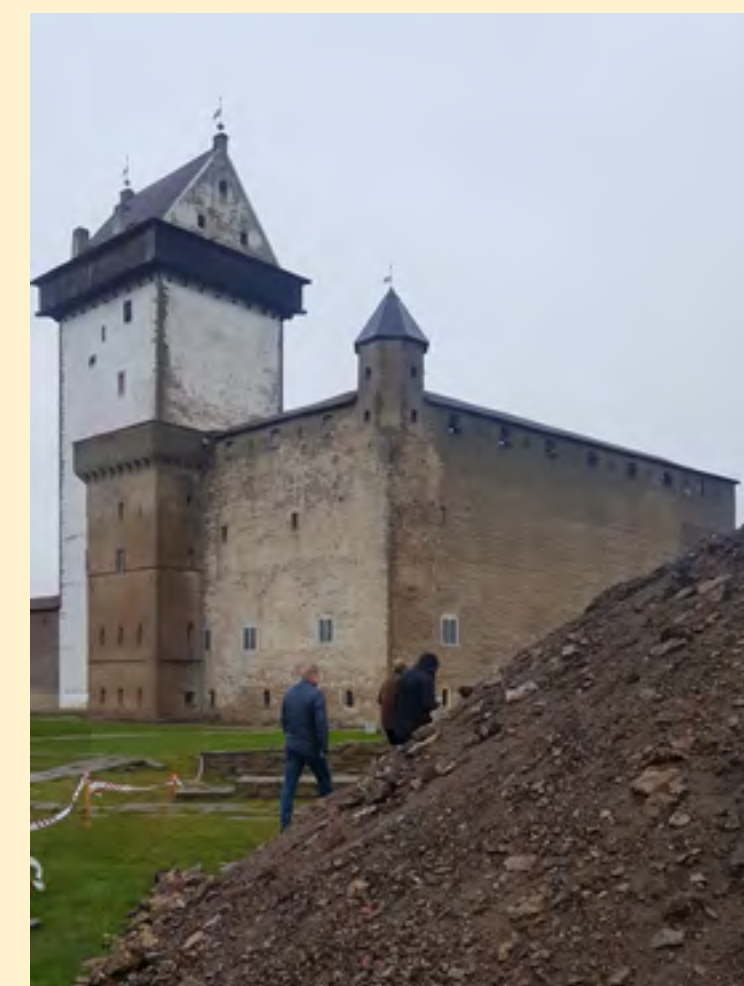
13—14  
Reconstruction of the Western  
Courtyard. 2023. Narva Museum

In autumn 2020, the Museum started restoration activities in the Western courtyard. By spring 2021, the northern wall, which prior to that had been in a dangerous condition, was restored. At the end of 2021, preparation to complex restoration of the western courtyard started, and in summer of the following year, the area and scale of work were enormous. (Images 13, 14) Archaeological excavations were in progress, complicated drainage works were carried out in the casemates and on the surface of the Kristervall half-bastion. Specialized machines were sieving the soil to separate and sort out stones, because in different places throughout all the site only the soil and cobblestones were used that had already been there. At the same time, suddenly the smell of horse manure could be felt in the Western courtyard. According to the archaeologists, it related to the exposed layer of ground of the 17th century.

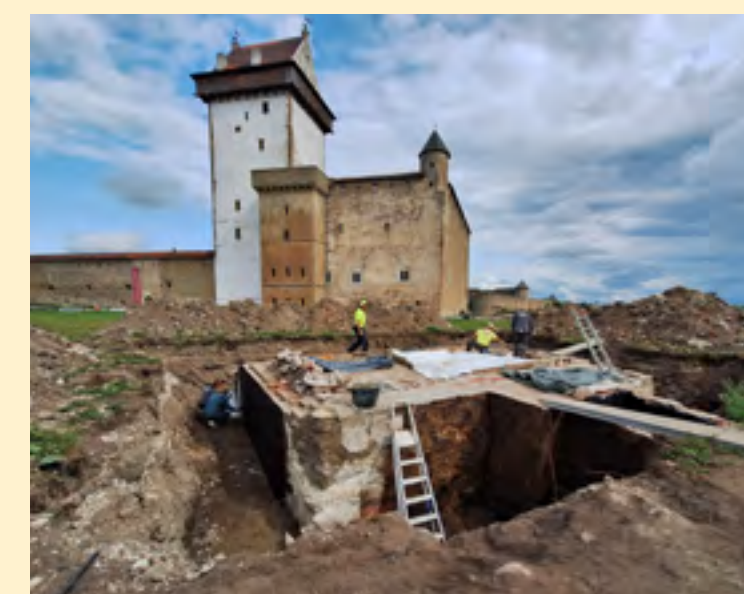
15 Conservation of the cellars  
discovered in the Western  
Courtyard. 2023. Photo:  
Maria Smorzevskihh-Smirnova

The western courtyard sprung a whole number of unexpected findings, the most significant of which was a structure with vaulted undercrofts found under a thin layer of ground. (Image 15). The structure was cleared out and various options for its further history. Anyway, in autumn 2023, the decision was made regarding to its conservation, for the initial designation of the structure was unclear. By a fortunate coincidence, these undercrofts did not collapse, and nobody was injured during the time when large-scale events, including those when heavy-duty transport means were used, were held in the western courtyard. Thorough conservation of the structure found will give the possibility to preserve that for studying, and, presumably, for exhibiting that in the future.

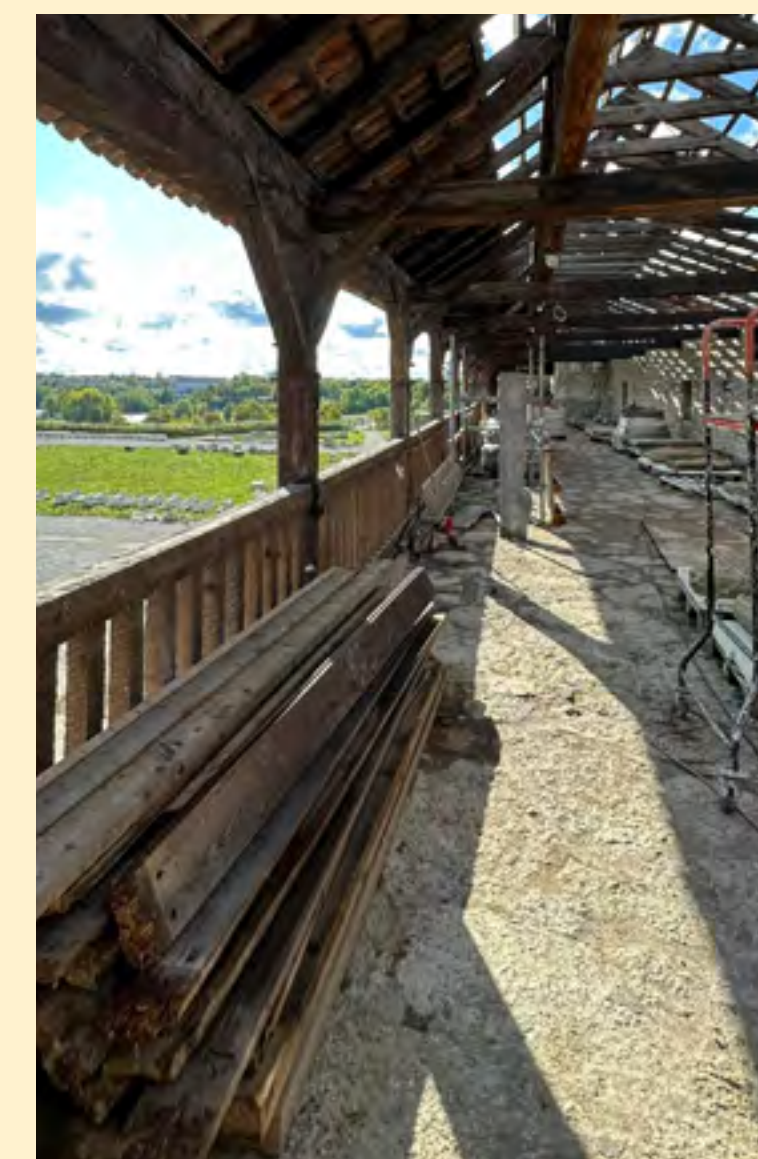
16 Restoration of the roof of  
the Western wall. 2023. Photo:  
Maria Smorzevskihh-Smirnova

the expert evaluation paid by the Ministry of Culture. It was found out that in the 1970s, the wooden bars were installed with serious breaches, which resulted not only in the emergency condition of the tiled roof but in the danger of wooden structure collapse. The decision was made to carry out extra works and to replace not only the tiles but the wooden structures along the full length of the summer gallery. (Image 16)

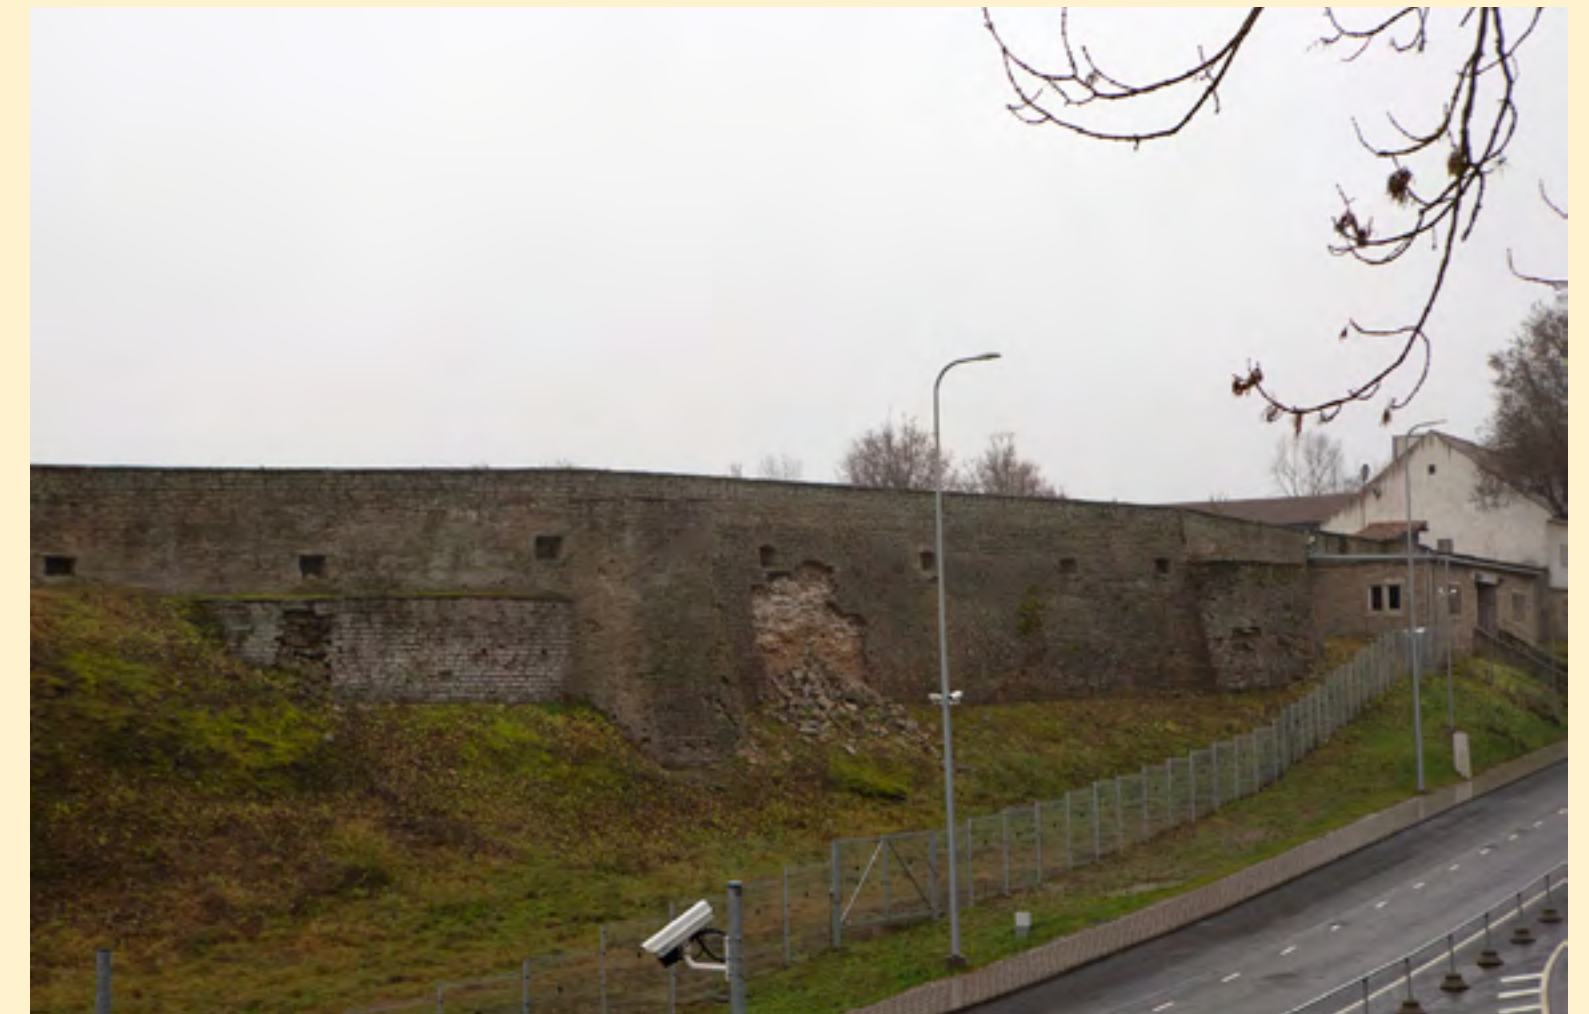
The collapse of the northern wall of the western courtyard. 2015

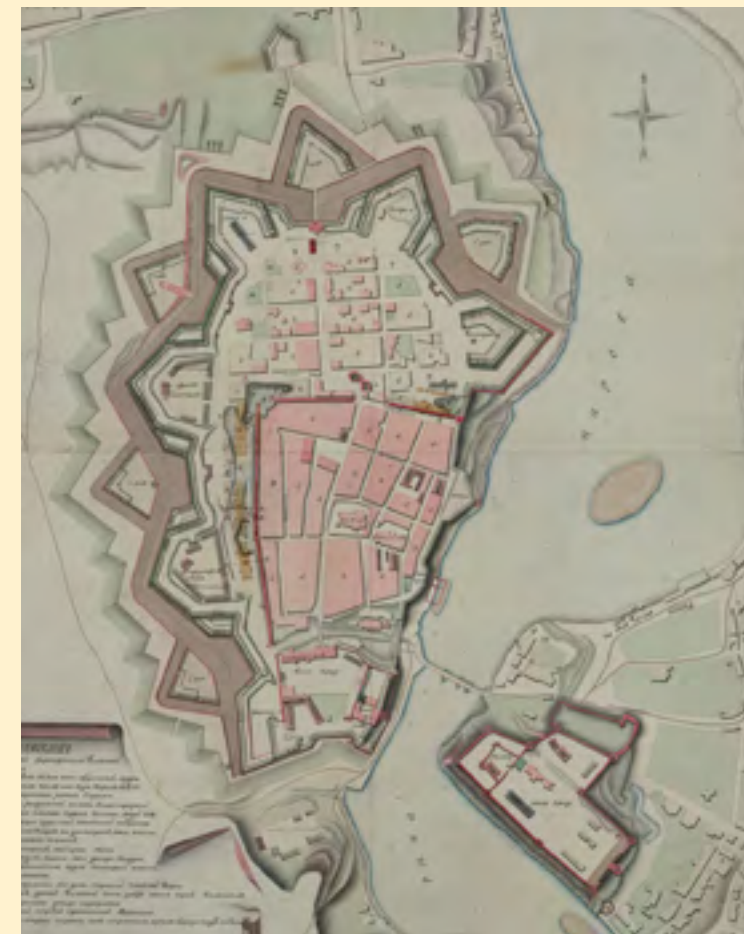
Plan of Narva and Ivangorod fortifications. 1797. RGIA

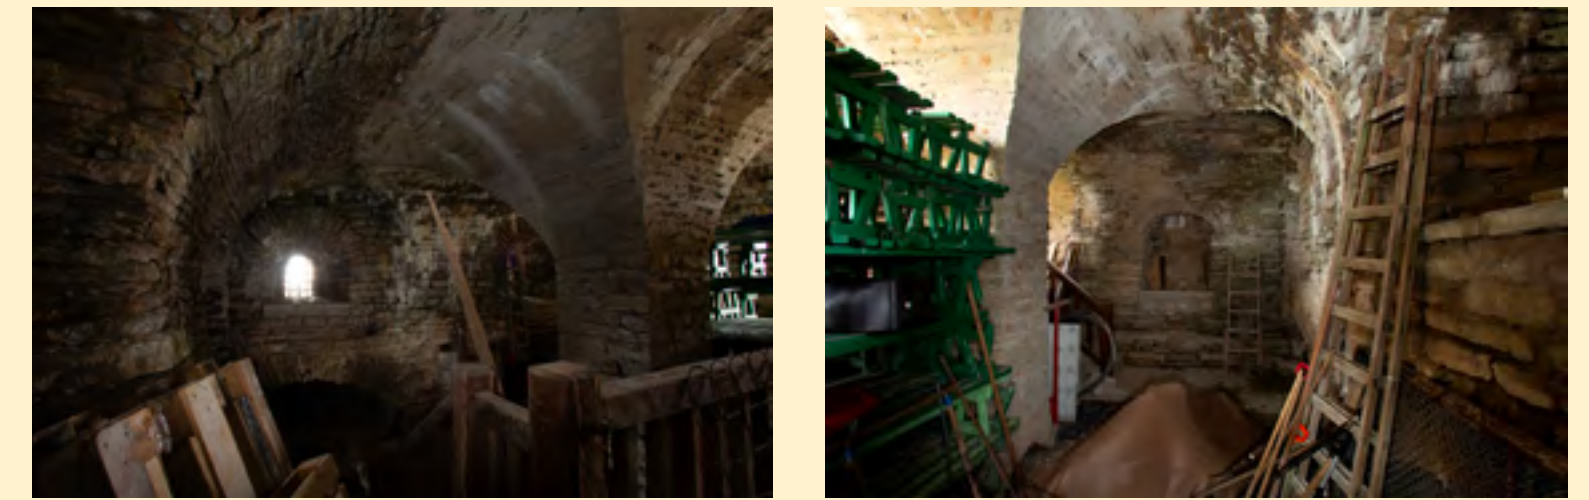
Casemate in Kristervall before restoration. 2015

Inside Kristervall, there is a casemate: a vaulted chamber or passage built into the defensive earthwork that was used as a shelter, a ration supply depot or a firing position, as well as for moving between the various parts of the fortification. The casemate flanked on the right side of Kristervall half-bastion was built to defend the main gates of Narva fortress. Upon the construction of Kristervall, it was not the artillery fire that posed the major threat for the gates of the fortress but petards – explosive charges of a couple tens of kilograms in weight – that were used by enemy sappers to try to blow up the reinforcement of the gates. Kristervall casemate aimed at the repulse of such attacks. For that purpose, two fast-firing cannons were placed in the main chamber of the casemate near the embrasures and could be used to shoot down

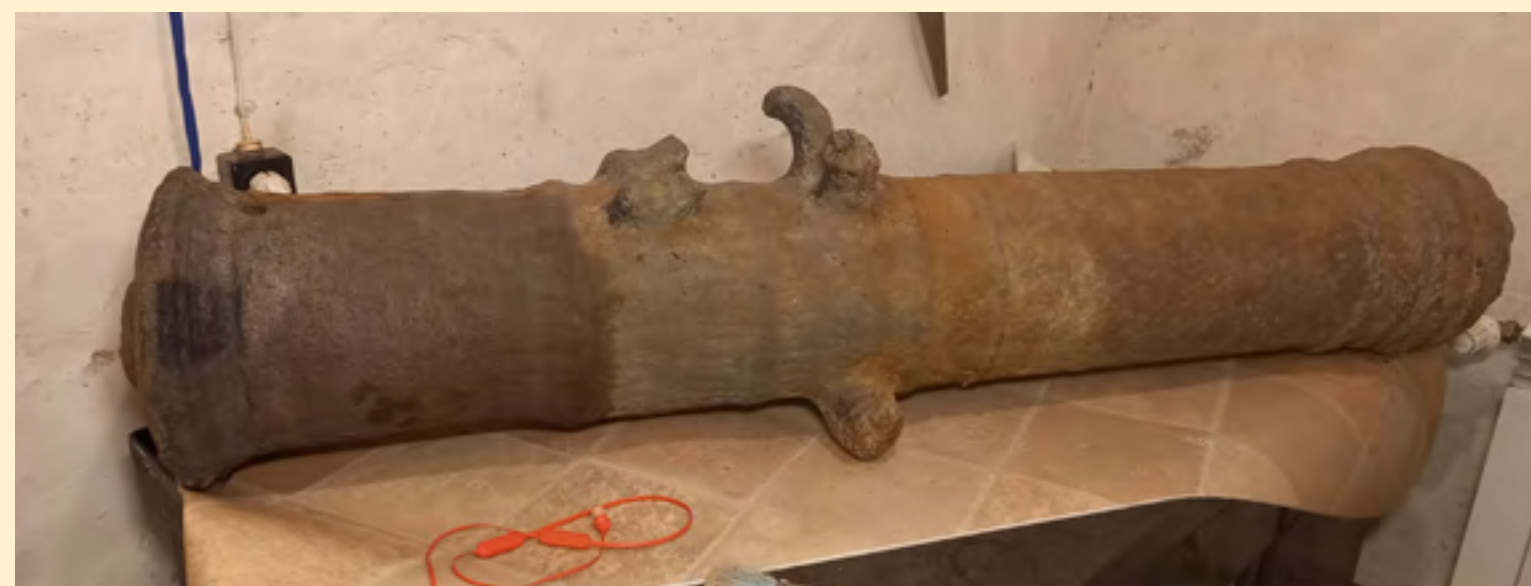
The 17th century Swedish cast iron cannon before conservation.  
Photo by Jelizaveta Pratkunas. 2023

To give the prominence to the military function and to create the relevant atmosphere, in one of the embrasures in the interior part of the bastion a Swedish cast iron cannon dating back to the beginning of the 17th century is displayed, which is placed on a new gun carriage specially manufactured for that purpose.

After the Livonian War, Northern Estonia belonged to the Kingdom of Sweden, and to protect their new domain in the Baltic Sea region ancillary armament for the Estonian fortresses was needed. In the middle of the 16th century, at the order of Karl IX (Charles IX) the copies of copper cannons were manufactured of cast iron in quick time and at a cheap price. They could be used during a siege both for defence and attack, as well as for setting fire to enemy's fortresses.

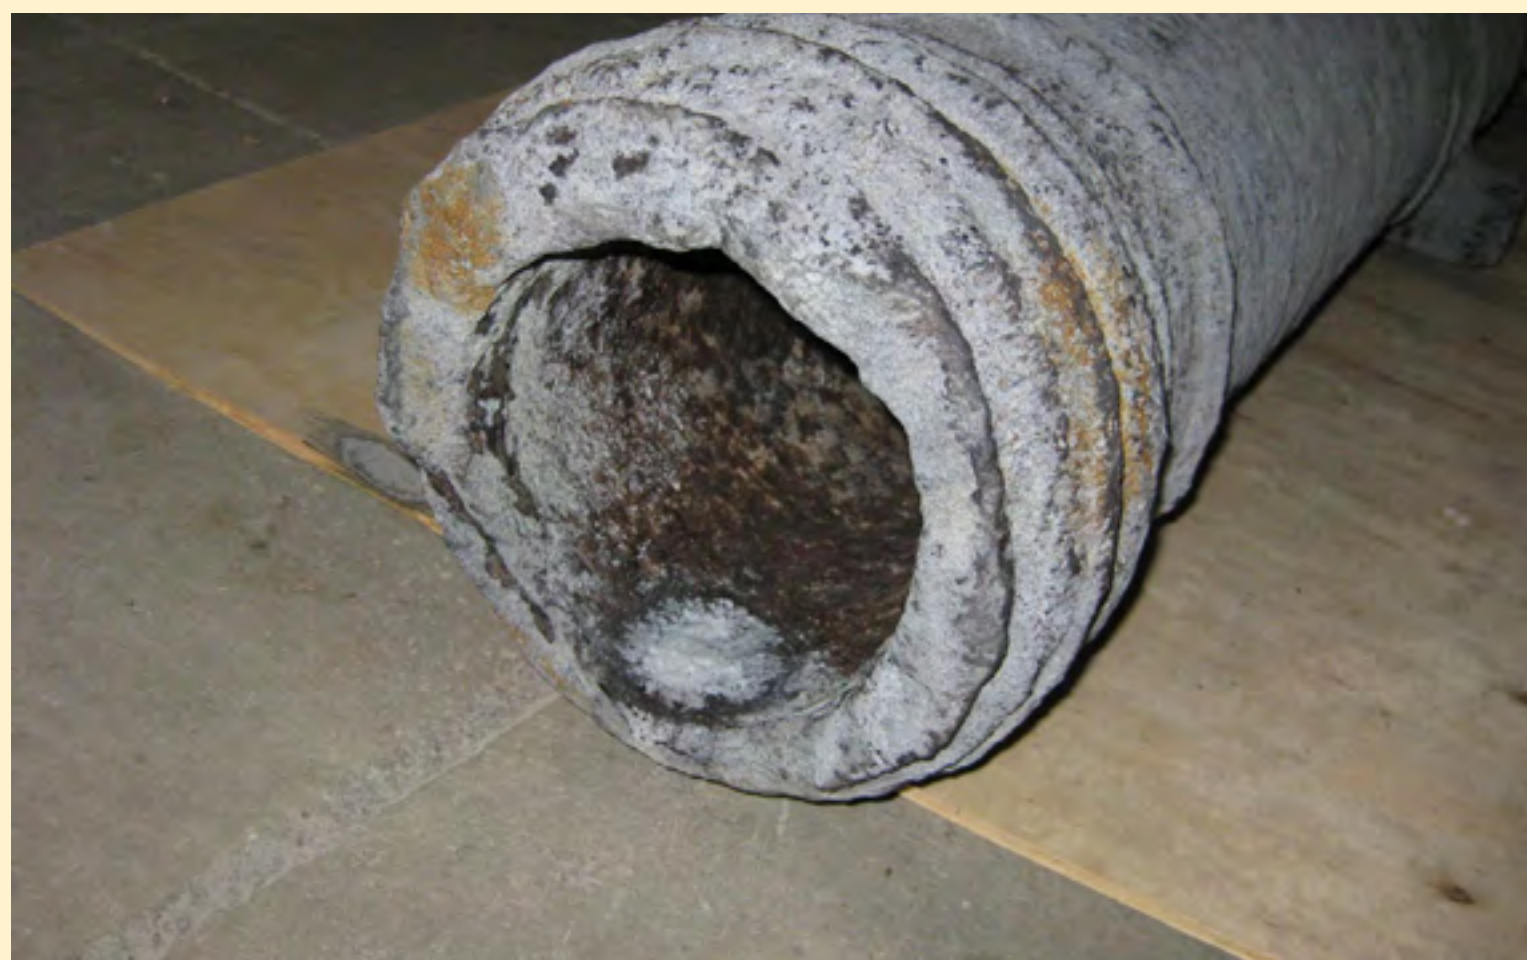
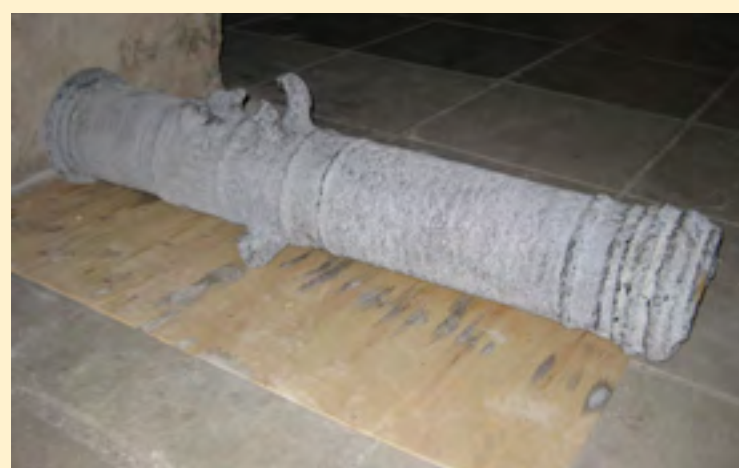
The 17th century Swedish cast iron cannon before conservation.  
Photo by Vadim Bulatnikov. 2017

The cannon came into Narva Museum collection in 1990 being in rather poor condition and desperately needing preservation. You can find more about the cannon in the Museum

Public Portal (NLM 1789:4 R 57:4). Owing to the Project, a chance occurred to carry out necessary work and to give the cannon a decent look. Restoration work was carried out by a Narva Master's student of the Estonian Academy of Arts, an alumna of Pallas University of Applied Sciences, lecturer Elizaveta Pratkunas. In the course of work, the cannon was cleaned both inside and outside and coated with a protective layer, which will help in the future to remove corrosion more easily and to ease the cannon servicing. That way, the cannon can be safely displayed in

the authentic space of Kristervall half-bastion all year round. For the cannon display, Saaremaa artisans manufactured a gun carriage.

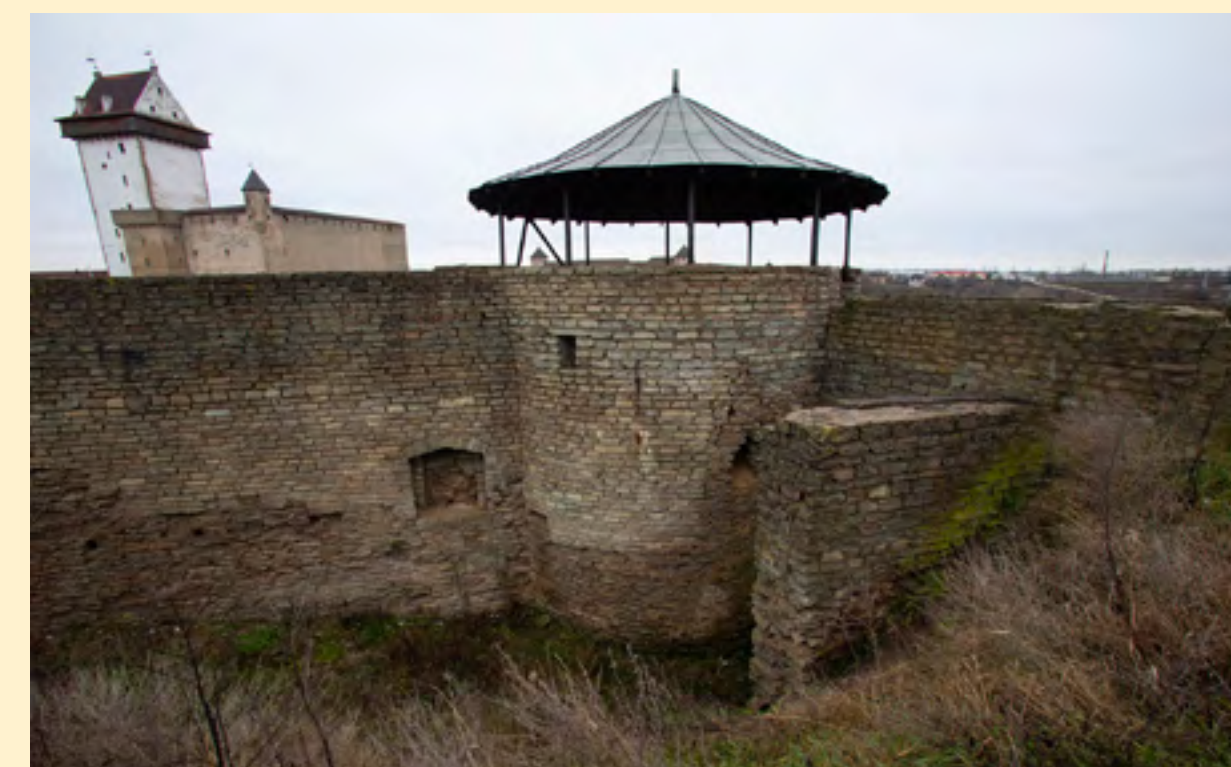
Medieval south-west tower in half-bastion Kristervall. 2015

flank), as well as the sloping stall. If the earlier project had envisaged liquidation of all existing structures in the southwestern corner of the fortress (including the munition depot), the final solution was more moderate. The old Kristervall half-bastion was redesigned to provide a higher level of defence (turning factually into a cavalier) for the new bastion, having added a new flank at its riverside. Upon that, the remains of the mediaeval southwestern tower of the fortress were completely buried under the ground.

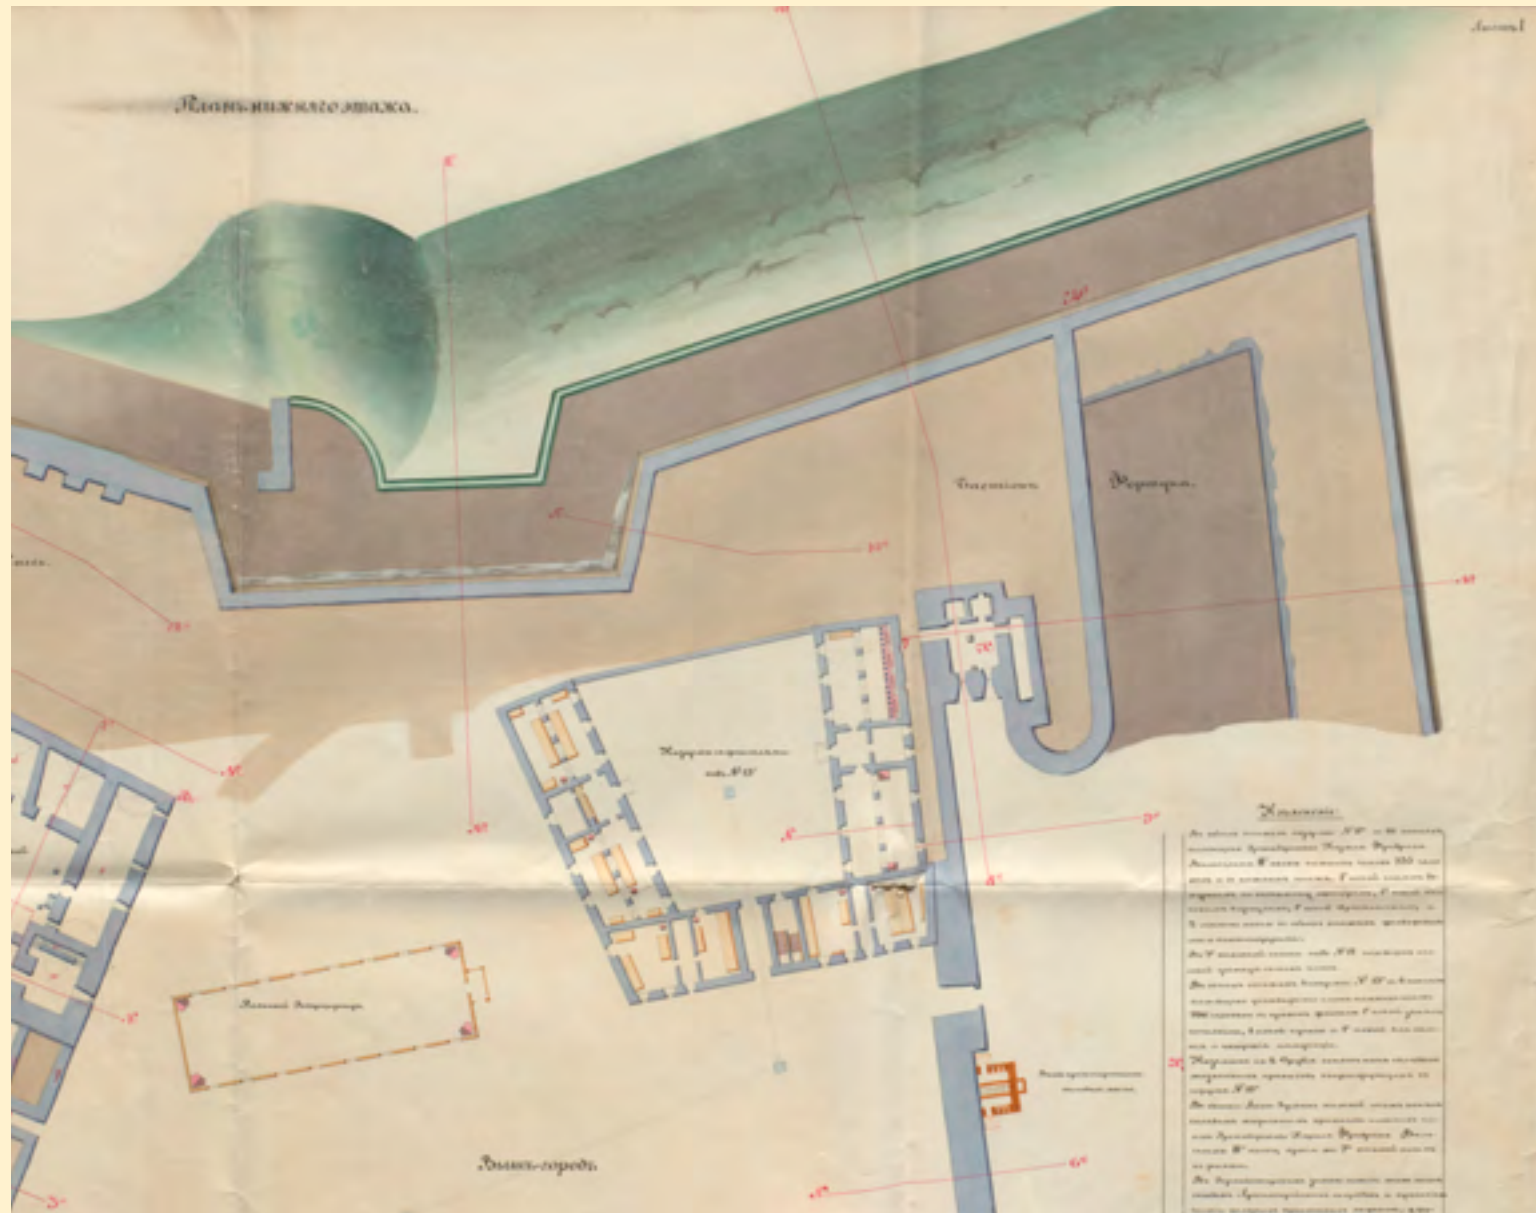
Fortuna Bastion with Kristervall and Arsenal adapted for its part.  
1841. RGVIA

Fortuna Bastion (from Latin – “fortune”) belongs to a new, wider circle of bastions erected at the end of the Sweden era in 1680s. For the siege in 1704, the Swedes hastily finished the construction of the half-bastion only, and even then as an earthwork. It was only after the Great Northern War, by the end of the 18th century, when the Russian military authorities completed the construction of Fortuna Bastion (including its Joaorg portion with the left

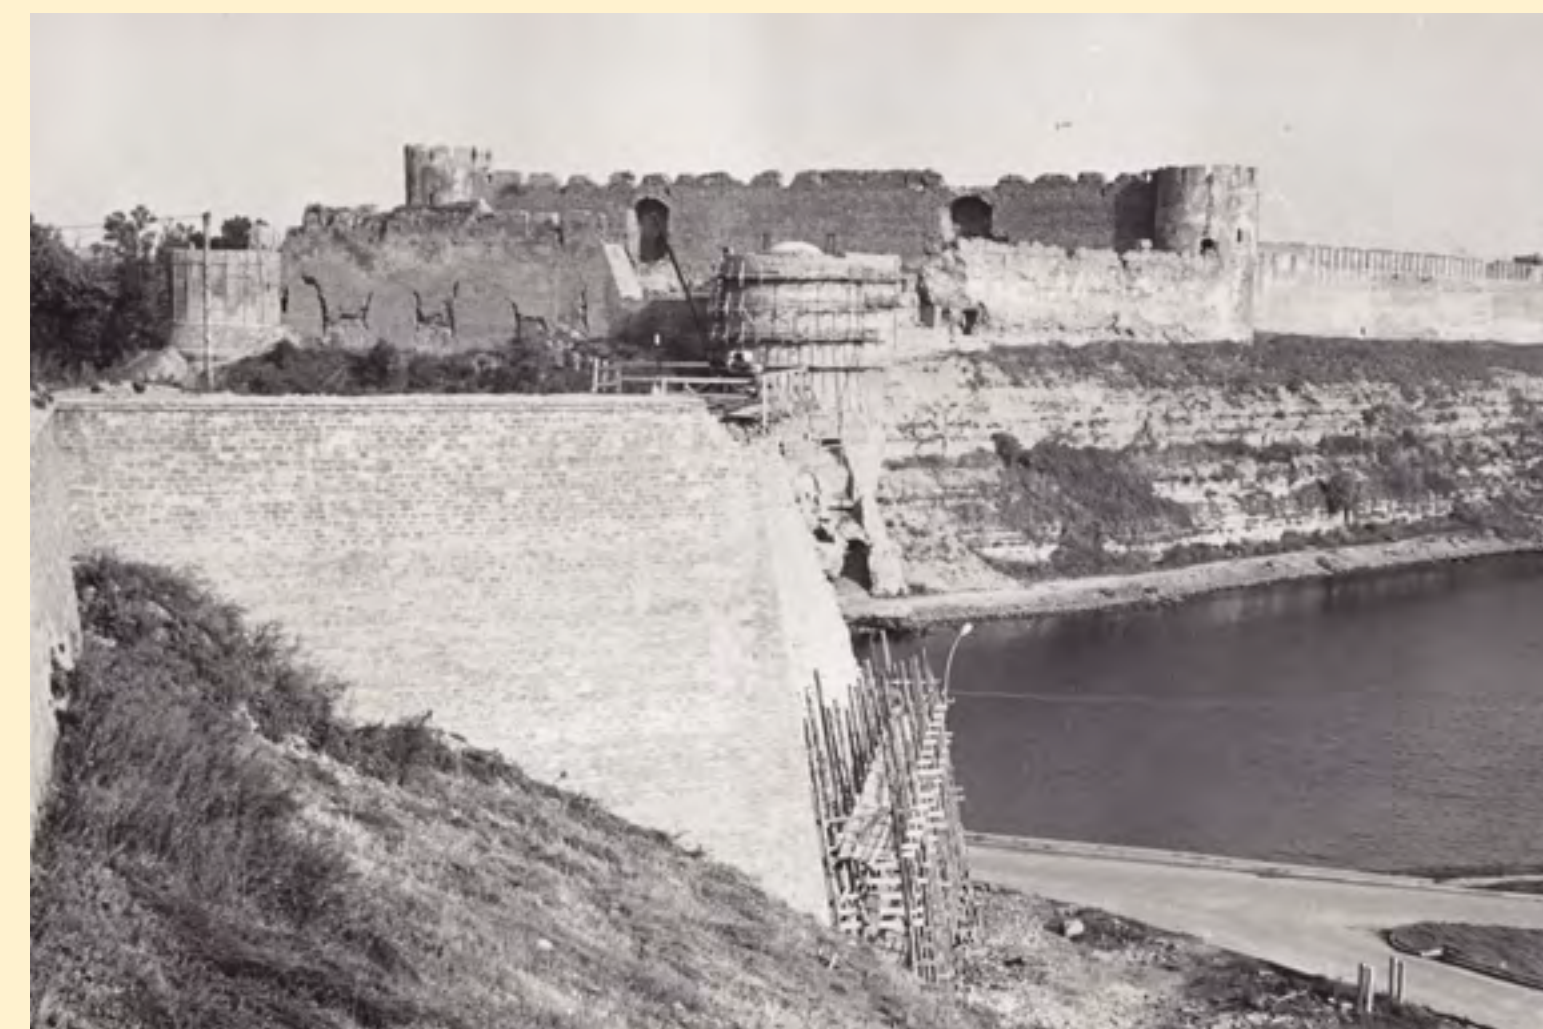
Restoration of the half-bastion Spes.  
Photo by Jevgeni Krivošev. 1973. Narva Museum

It was planned to be of the same height as the other part of the bastion, but in the end turned out to be considerably lower. At the end of the 18th century, when Sweden was again at war, Spes quickly took a defensive position. At the same time, the riverside part of Spes was designed as a two-level structure so that the lower defensive crenelated wall ran opposite the large dansker of the fortress. Moreover, at the bottom of the earthwork from the Joaorg side, an additional defensive position was built that included a hidden road and a glasis for the defenders to be able to move unnoticed and to put up resistance. Currently, the shape of the riverside part of Spes half-bastion has been made plainer. The exterior facing of the sloping walls of that and other earthworks was renovated in the course of restoration work that took part at the end of the Soviet era.

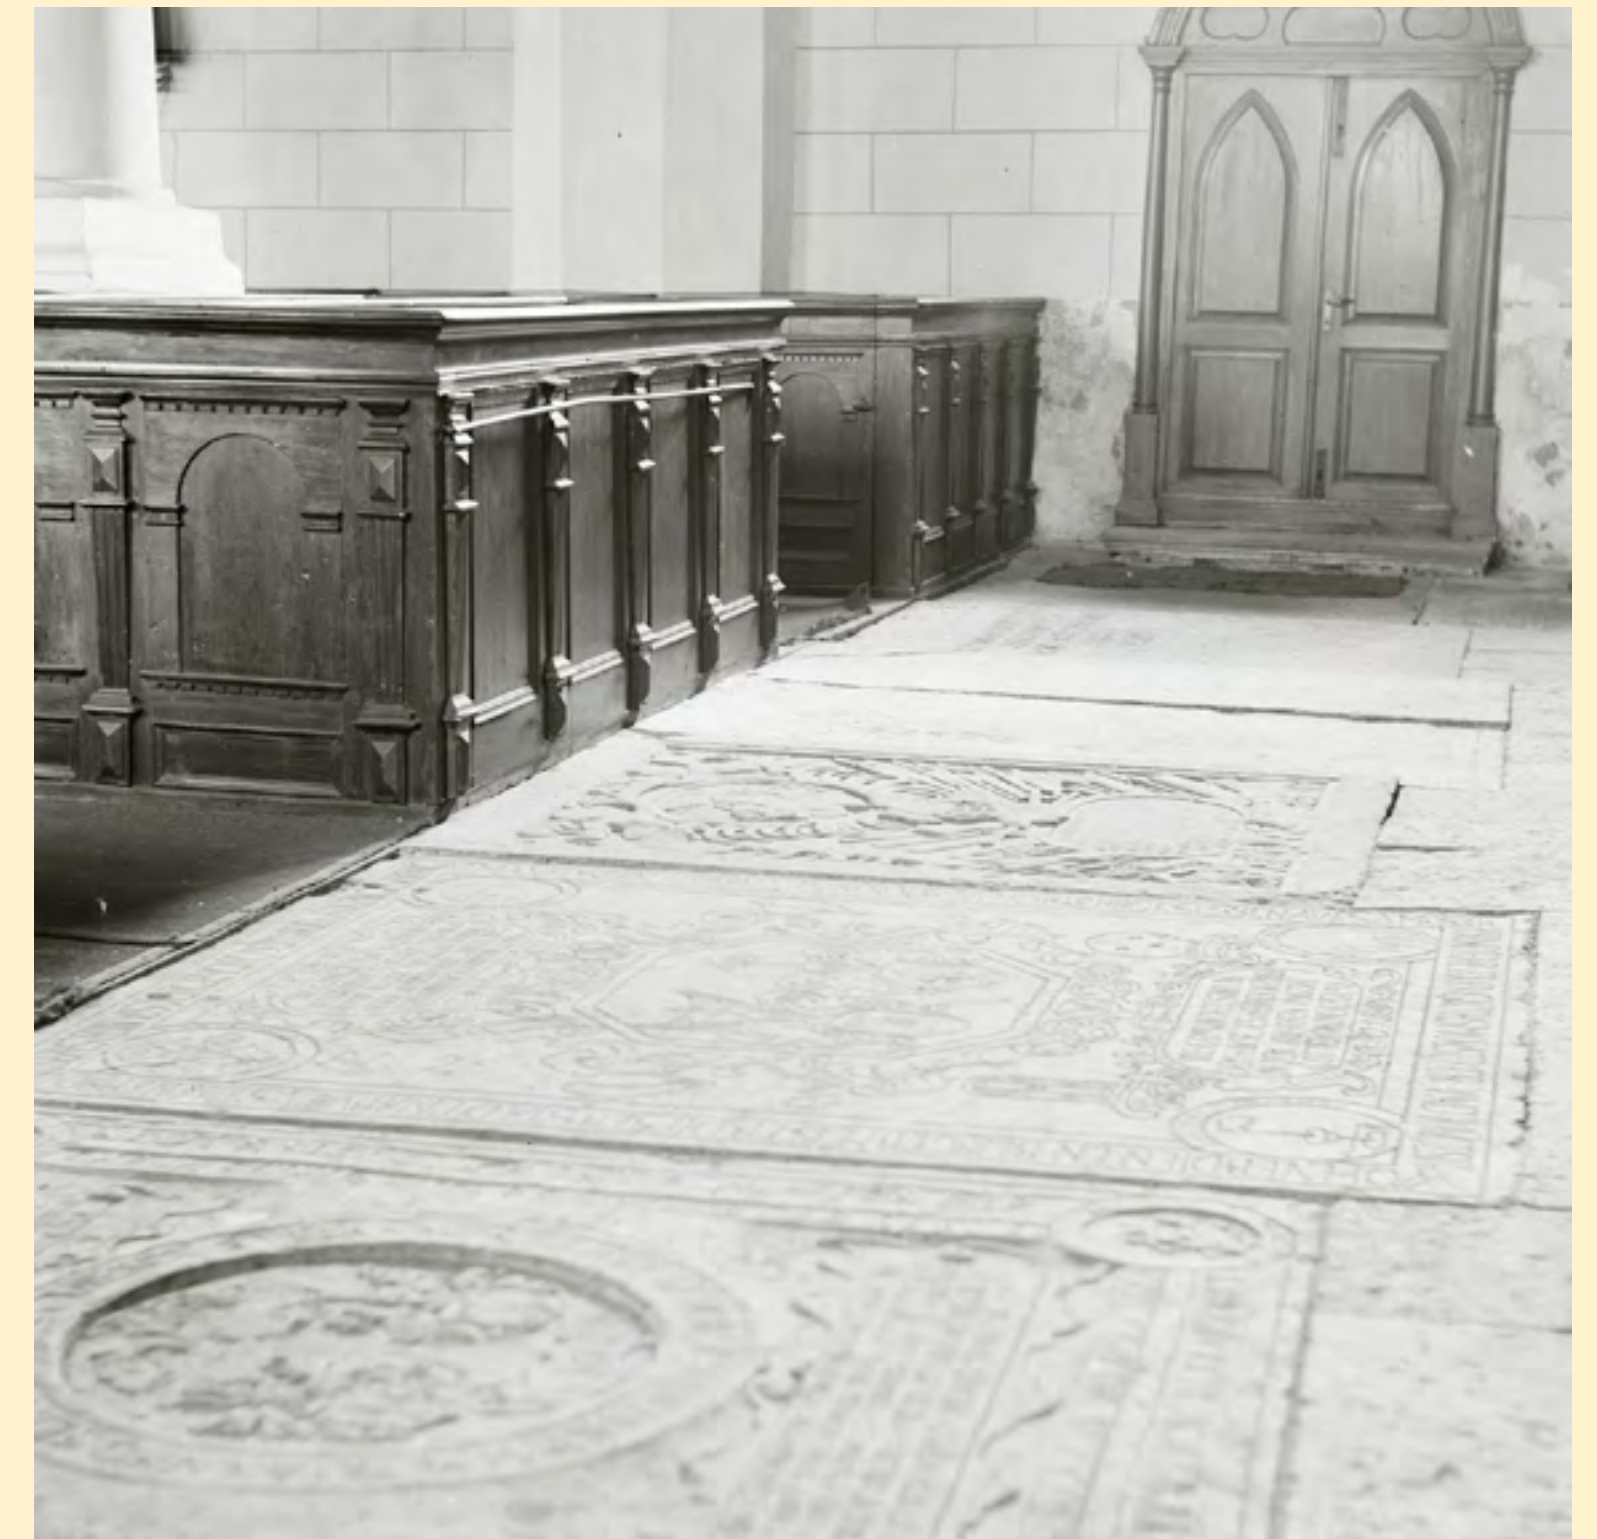
Gravestones at Narva's St. John's Church. Photo by Carl Sarap. 1939. Virumaa Museums Foundation

designs and decorations. The lettering on the gravestones helps to distinguish between churches. For example, the lettering on the gravestones in St John's Church was carved into the stone, while those in the Cathedral of

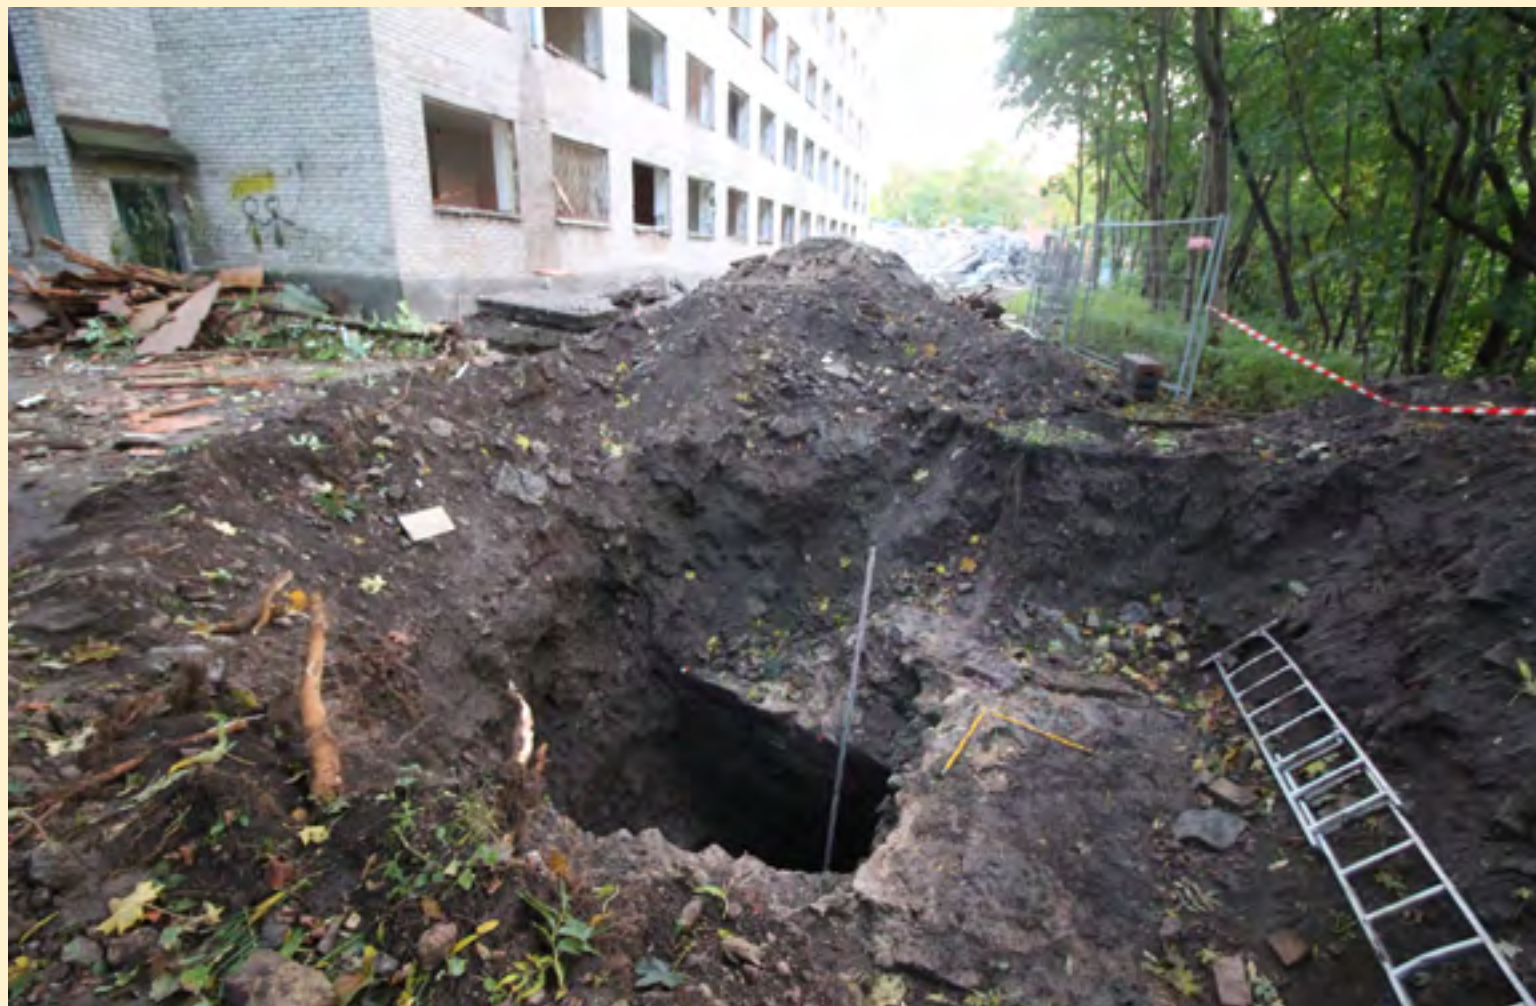
3. Shaft 1. Staircase on the left flank of the bastion.  
Photo by Villu Kadakas. 2023

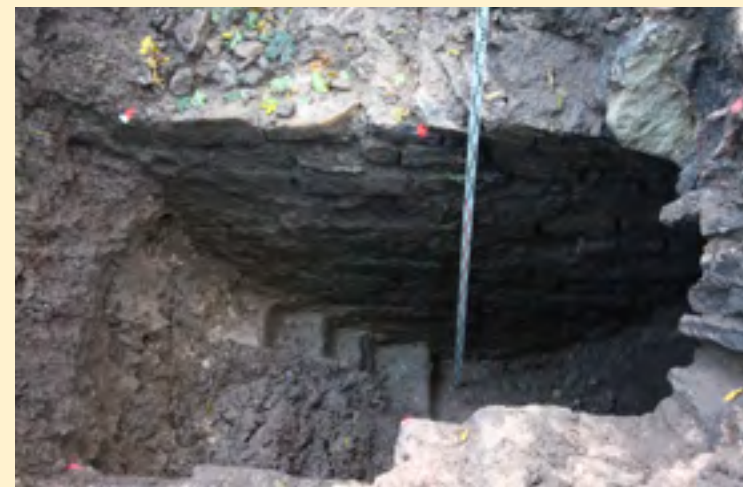
4. Shaft 1. Staircase on the left flank of the bastion. Cleaned out stair treads on the south-west side of the corridor.  
Photo by Villu Kadakas. 2023

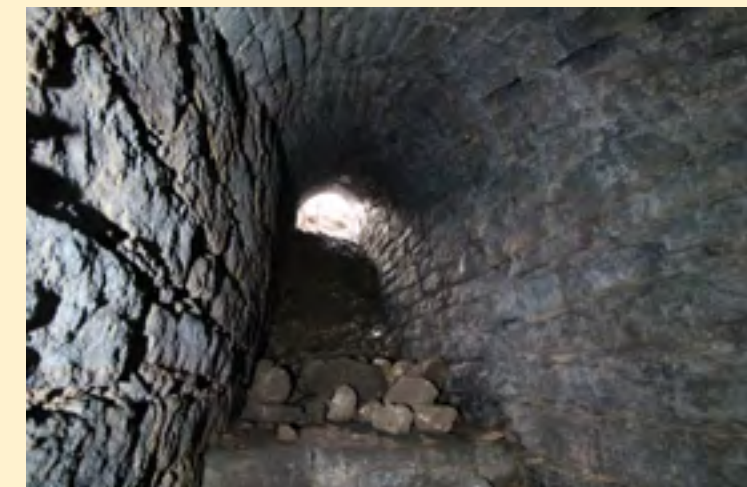
5. Shaft 1. Staircase on the left flank of the bastion. Cleaned out stair treads on the south-western side of the corridor, wider stair landing in the foreground.  
Photo by Villu Kadakas. 2023
