# **Estonian EU External Borders Programme (ER3) Research Results**

### Archaeological research of building remains in the Western Courtyard of Narva Castle between 2020–2023

### Bastions of Narva Castle

### Narva Gloria Bastion archaeological research 2023

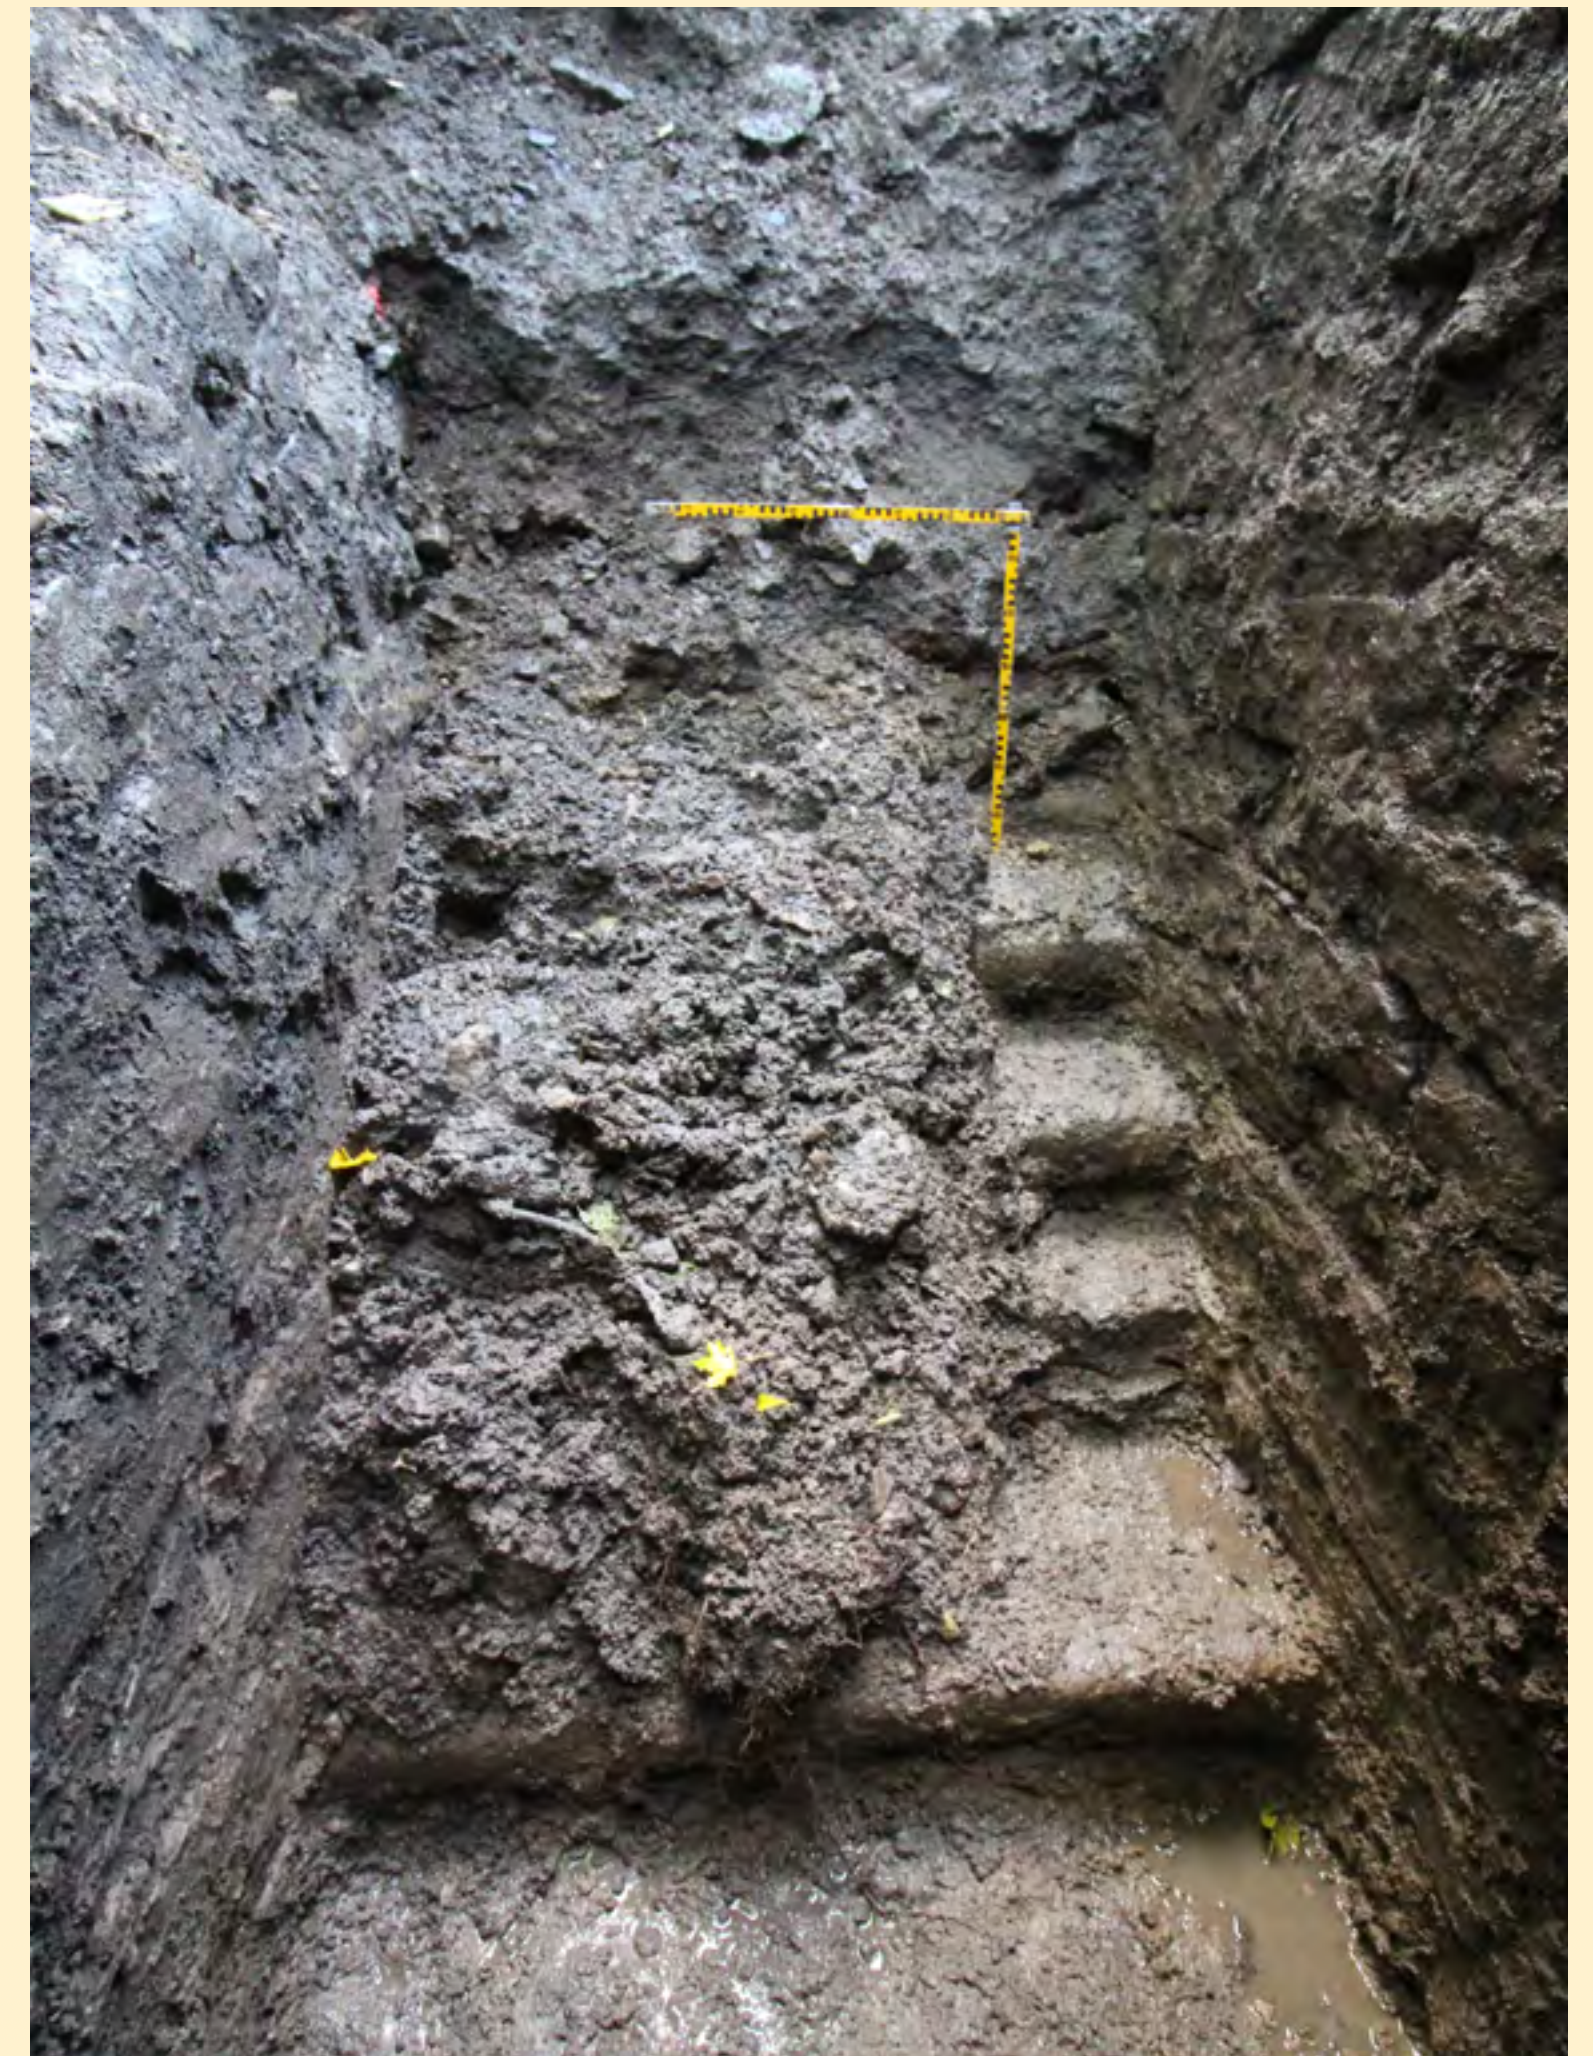
6. Shaft 1. Staircase on the left flank of the bastion, photographed from the bottom up towards the shaft. Photo by Villu Kadakas. 2023

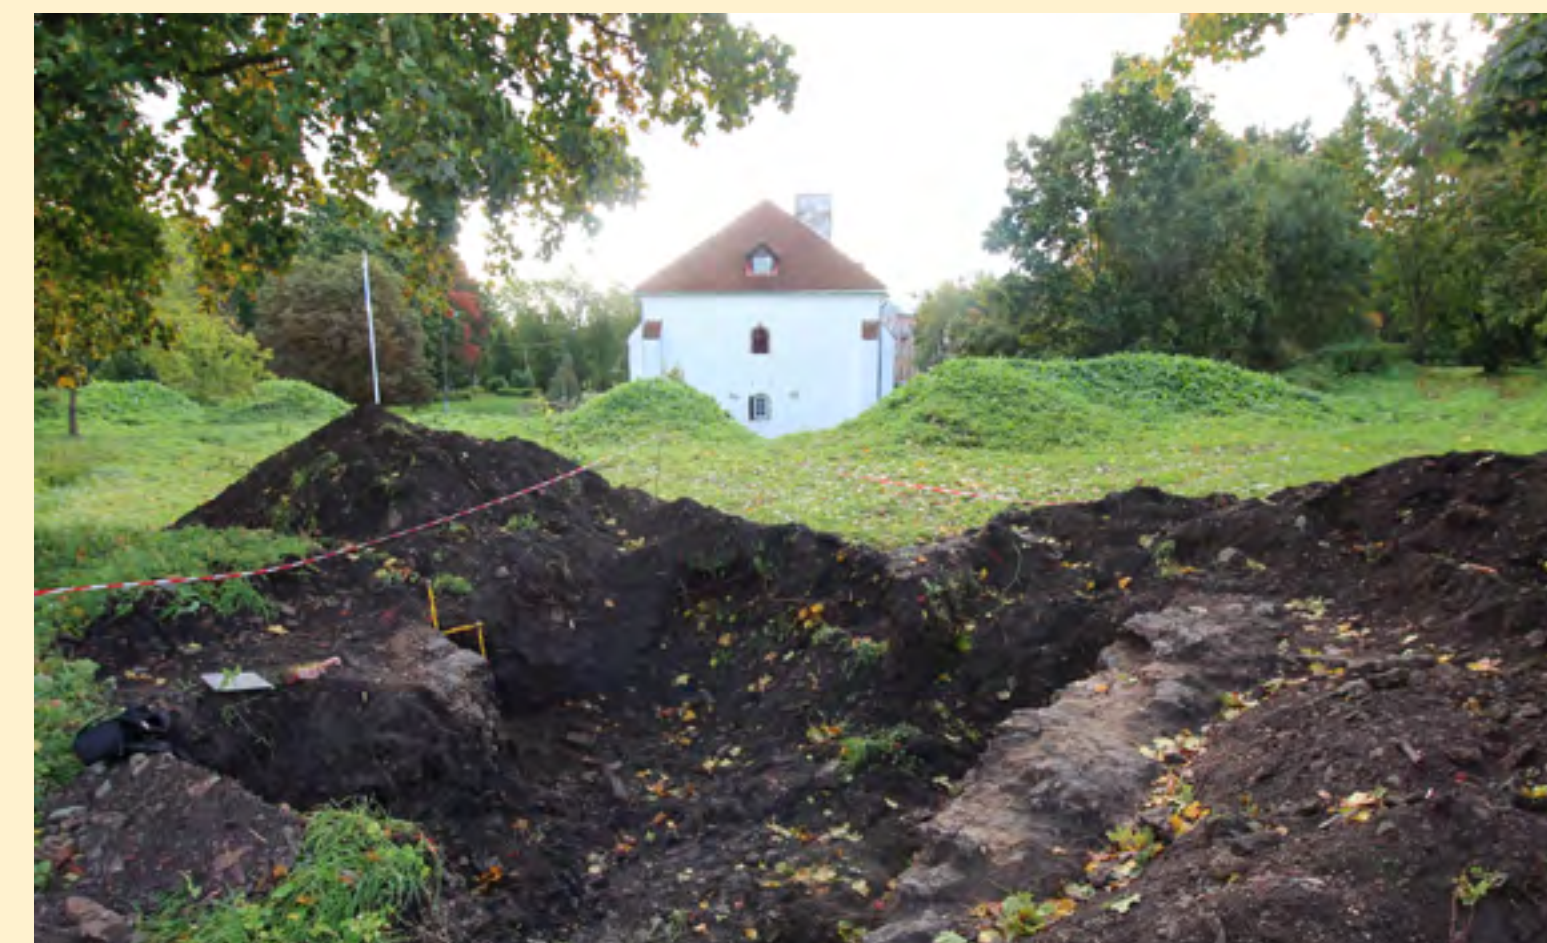
7. Shaft 4. On the left, remnants of the retaining wall of the inner side of the right face; on the right, remnants of the retaining wall of the inner side of the left face. View to the south-east. Photo by Ragnar Nurk. 2013

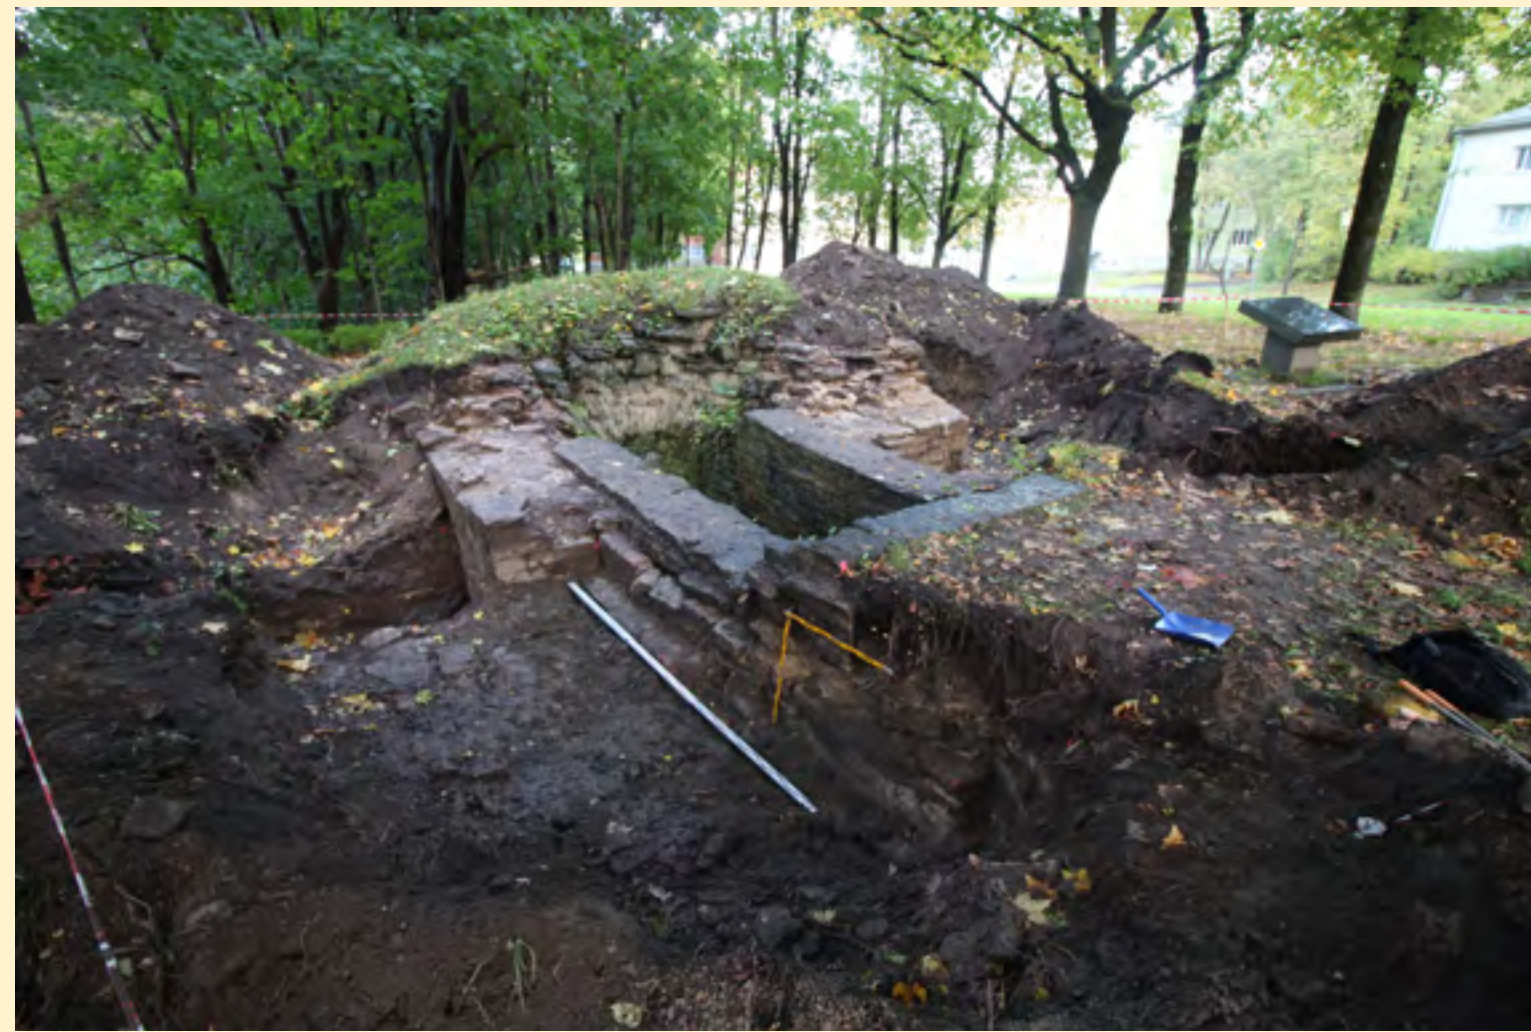
8. Shaft 5. The top of the stairway of the right hand flank.  
Photo by Villu Kadakas. 2023

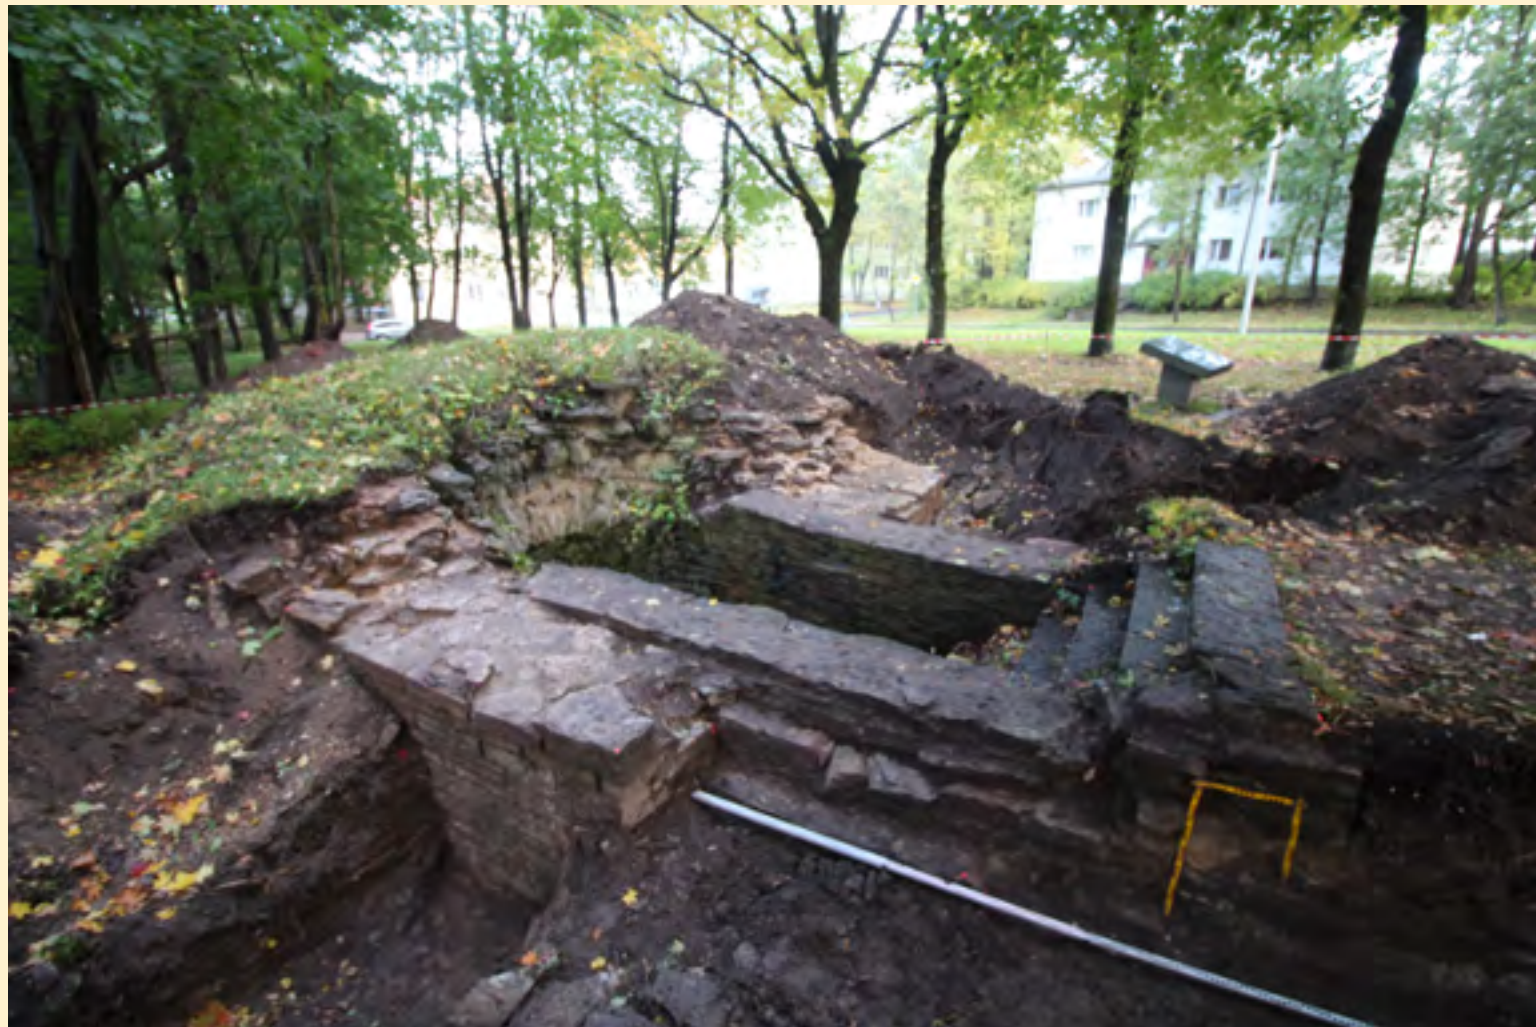
9. Shaft 6. North-western side wall of the stairway of the right flank, original brickwork on the left. Photo by Villu Kadakas. 2023

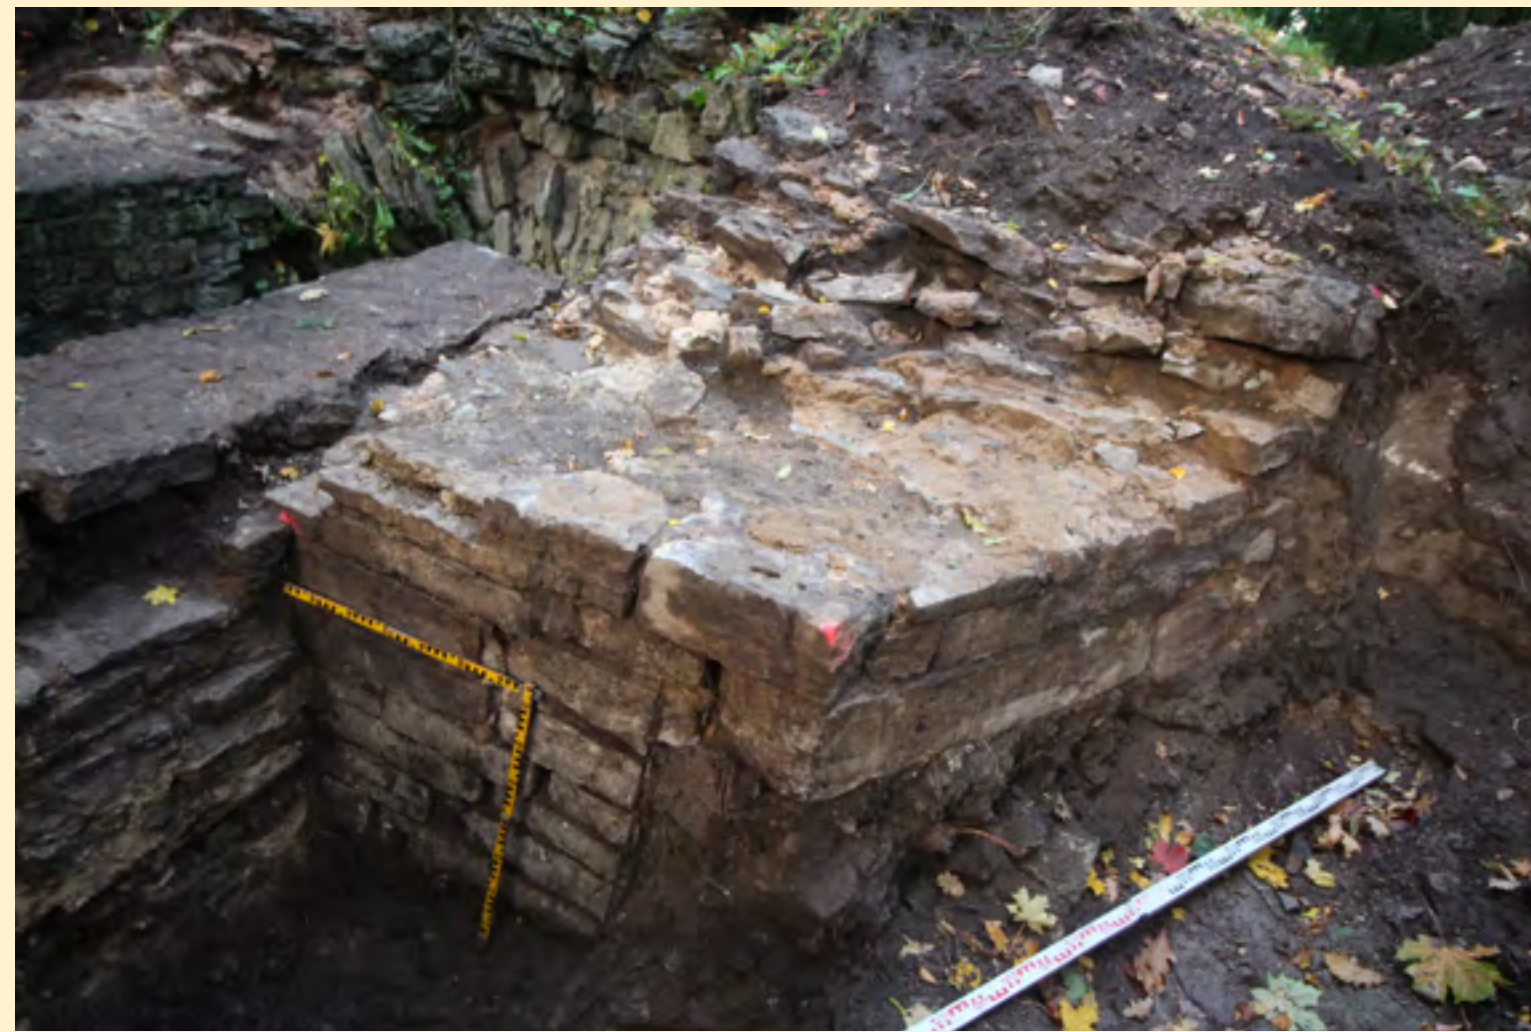
10. Shaft 6. The southeast side wall of the right flange staircase, in the foreground, the obtuse-angled outer side of the staircase side wall. Photo by Villu Kadakas. 2023

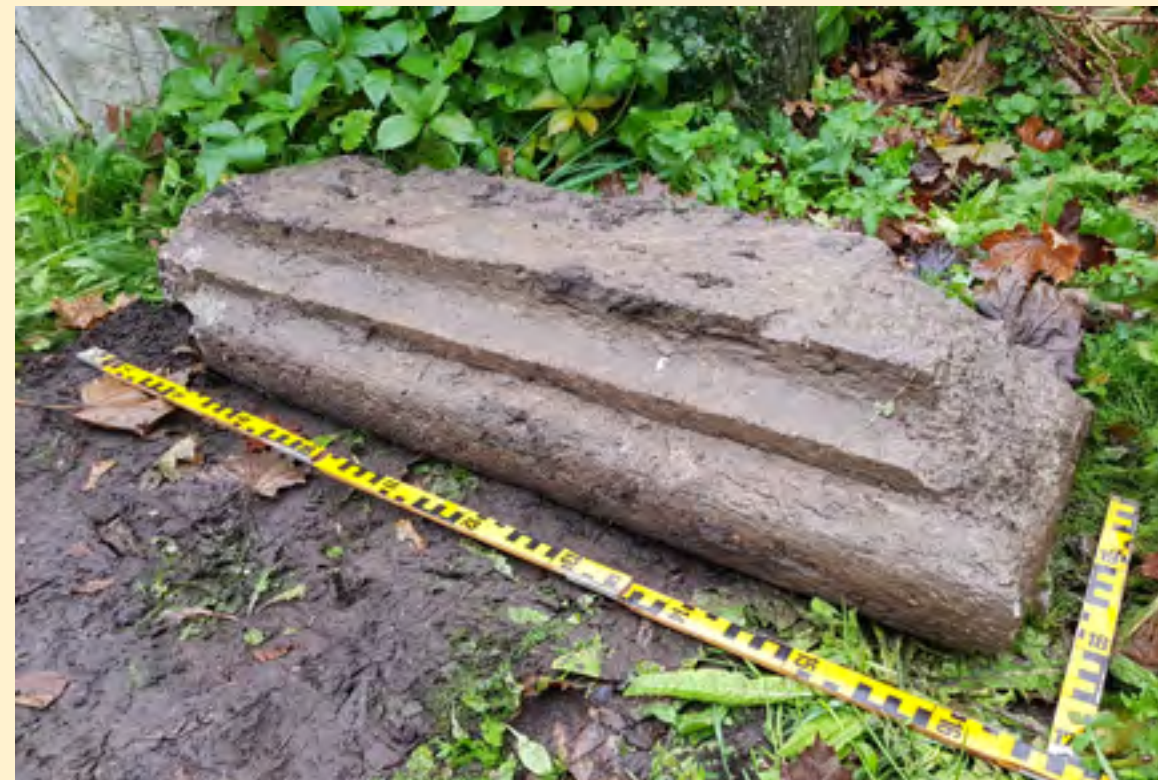
11. Shaft 6. Piece of a Swedish-era cornice. Photo by Villu Kadakas. 2023

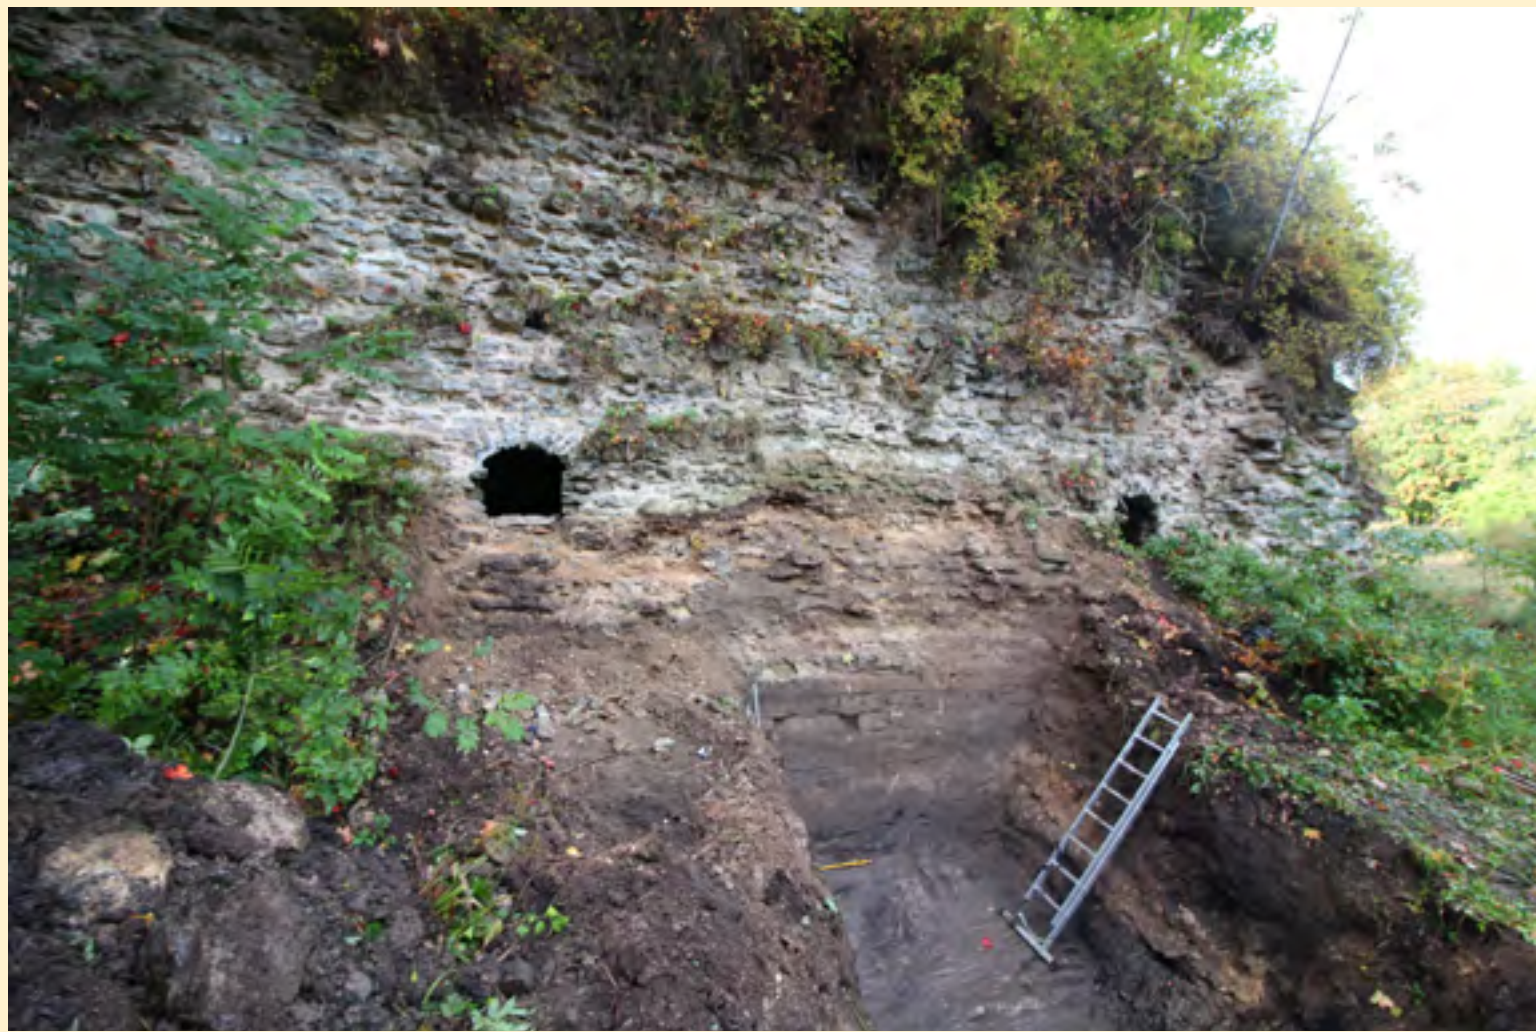
12. Trench 8 on the outside of the right-hand flank in the moat.  
Photo by Villu Kadakas. 2023
